NASA CR-1278

## PROPERTIES OF HIGH EMITTANCE MATERIALS

UNITED AIRCRAFT CORPORATION

NATIONAL AERONAUTICS AND SPACE ADMINISTRATION • WASHINGTON, D. C. • FEBRUARY 1969

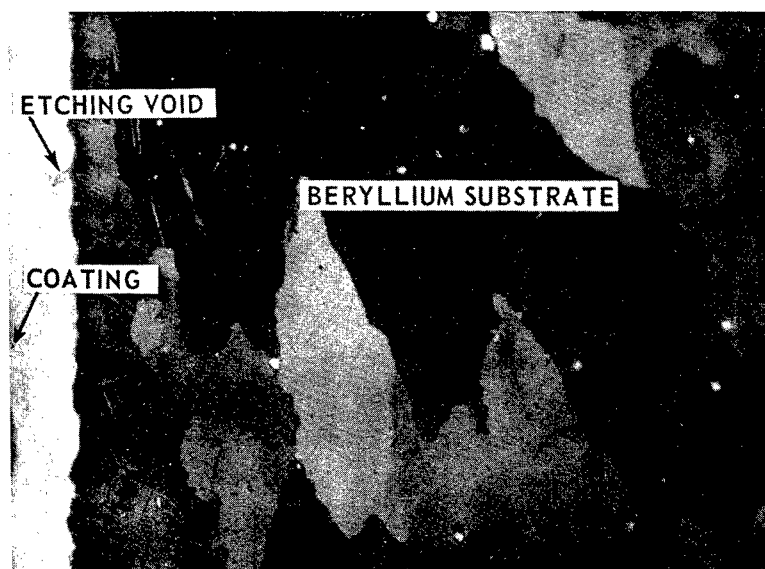
First Shipment 200X

The plates were received in two shipments, each from different heats, and the microstructures of the material differed significantly between shipments. As shown in Figure 1, the material received in the first shipment was characterized by elongated grains, whereas the material received in the second shipment consisted of equi-axed, recrystallized grains. The white streak in the photomicrograph at the coating-substrate interface was produced by coating material removal during specimen preparation. Cross-hatch lines in the substrate materials are indicative of twinning caused by cold working.
